## **Introduction & Purpose**

# Structural Response of Columns Under Fire Loading

Adam Jakubowski, Senior, Fire Protection Engineering Mentor: Dr. Byungik Chang, Department of Civil Engineering

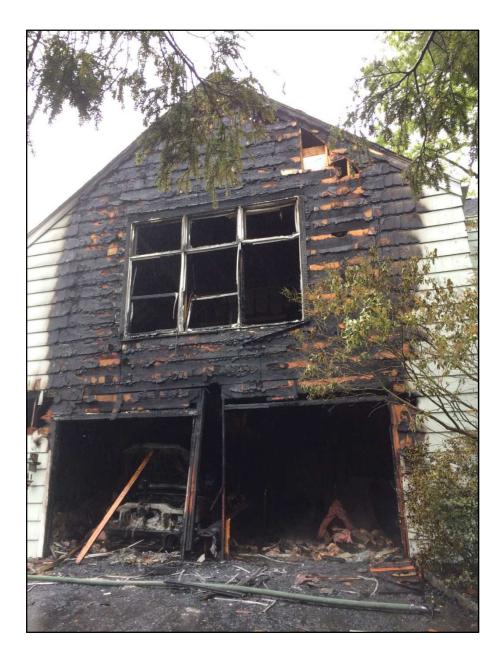
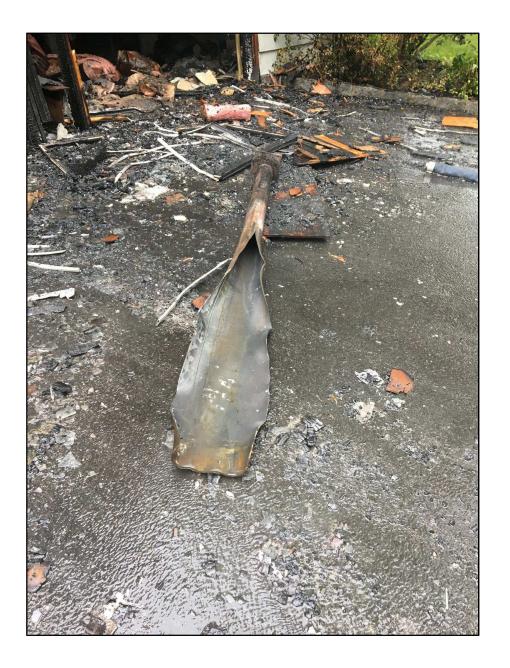
After instructing crews to advance a large attack line, the officer conducted a 360° size-up of the fire building. During this investigation, a loud explosion was heard. It was later identified that the cause of this explosion was the rupture of two columns supporting a W12x26 I-beam within the garage. One such column ruptured with enough force to penetrate an exterior wall, coming to rest in the driveway of the residence. Without remaining supports, the I-beam fell to the ground and resulted in a severely weakened structure, unsafe for crews to enter.

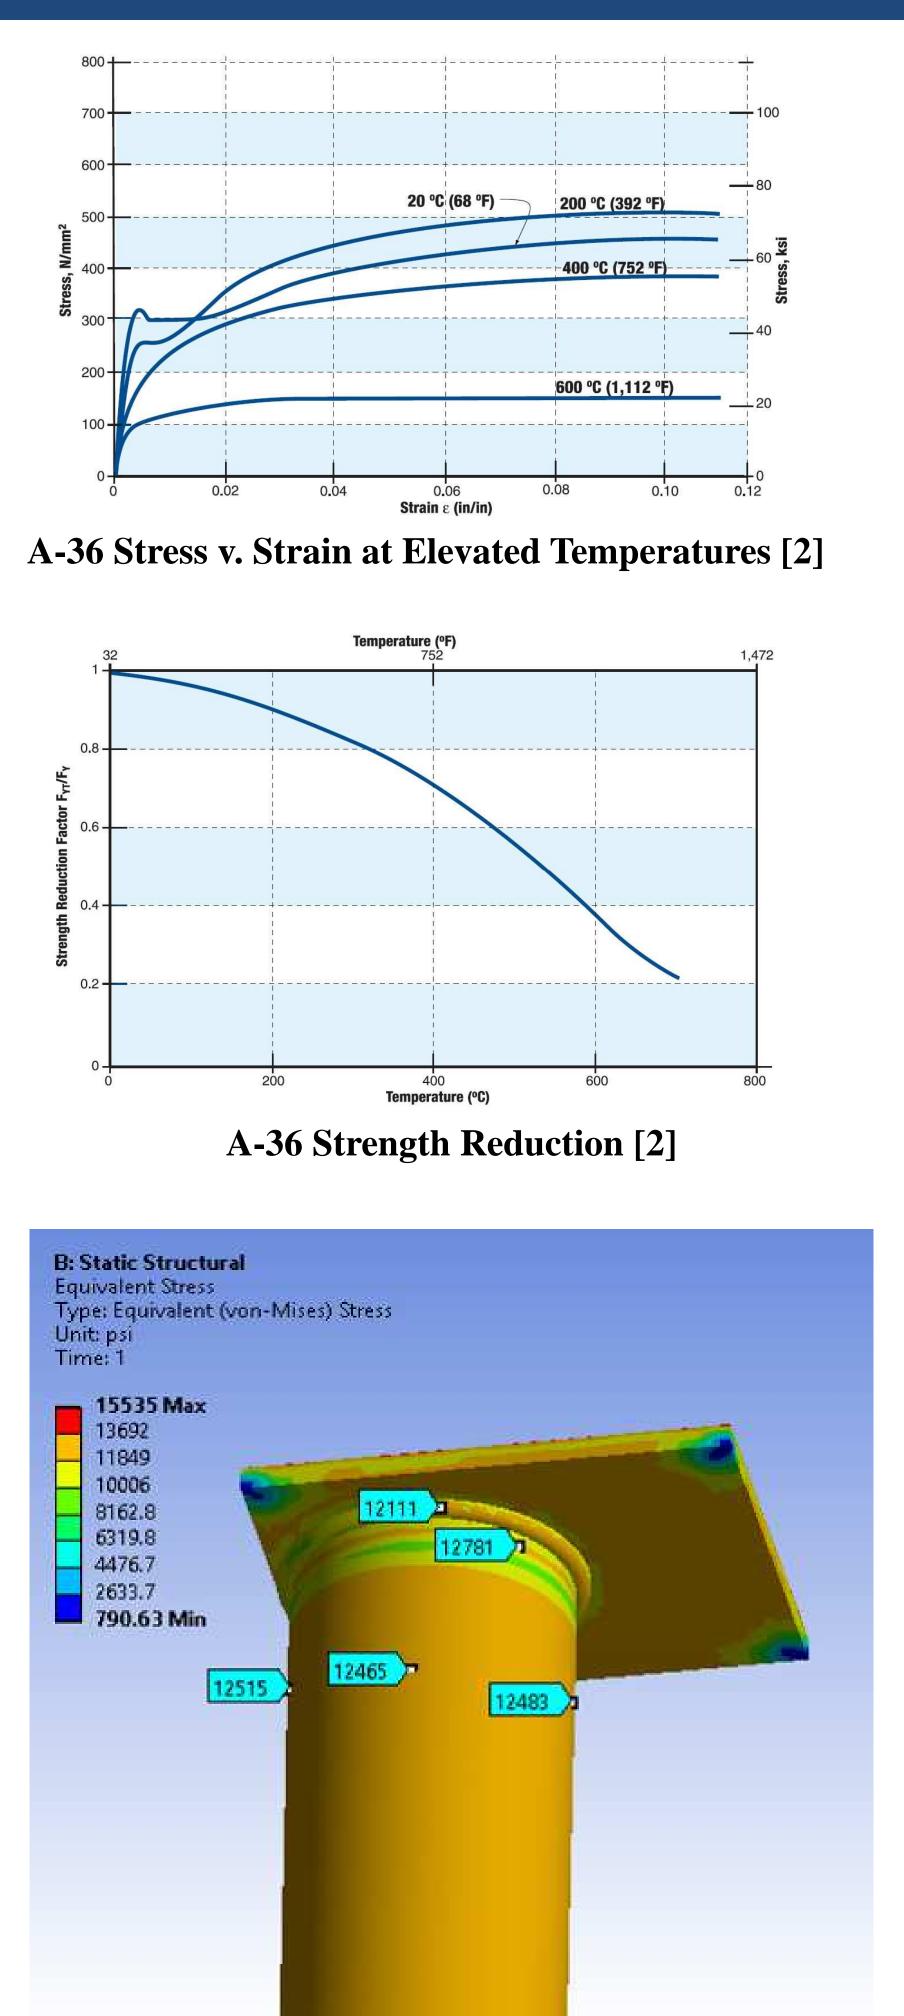
**Equivalent Stresses (Top of Column)**

- Based upon the applied thermal condition of 1200°F, it does not seem plausible that thermal stresses alone can cause column failure.
- The fixed boundary conditions utilized for this model may not be accurate in representing the boundary conditions for the true column.

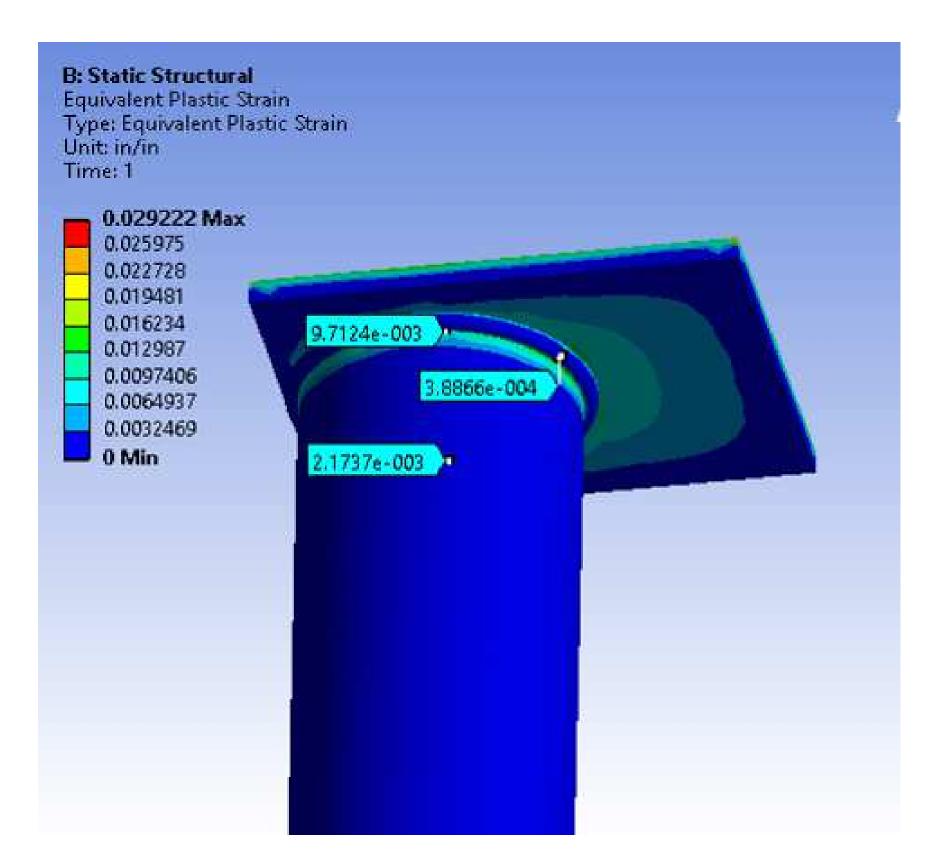
**Plastic Strain (Top of Column)**

• In addition to elevated temperatures, there are most likely additional factors that precipitated column failure: internal pressure caused by vapor expansion, the presence of a concrete core, buckling behavior, and eccentric loading.

• Firefighters responding to similar incidents must make an effort to cool structural components to relieve thermal stresses.
